PROJECT: Midnite Mine Remediation

REPORT NO: 2019-003

This weekly report provides a summary of Midnite Mine Site (Site) remediation action (RA) construction activities, quality assurance (CQA), quality control (CQC) and engineering activities for the period April 12-18, 2019. The Site activities discussed in this weekly report include, but are not limited to: Site Health, Safety, and Security; Community Liaison, Project Meetings, Regulatory Oversight, Site Visitors; Site Mobilization; RA Activities; Project Documentation; and Site Inspections.

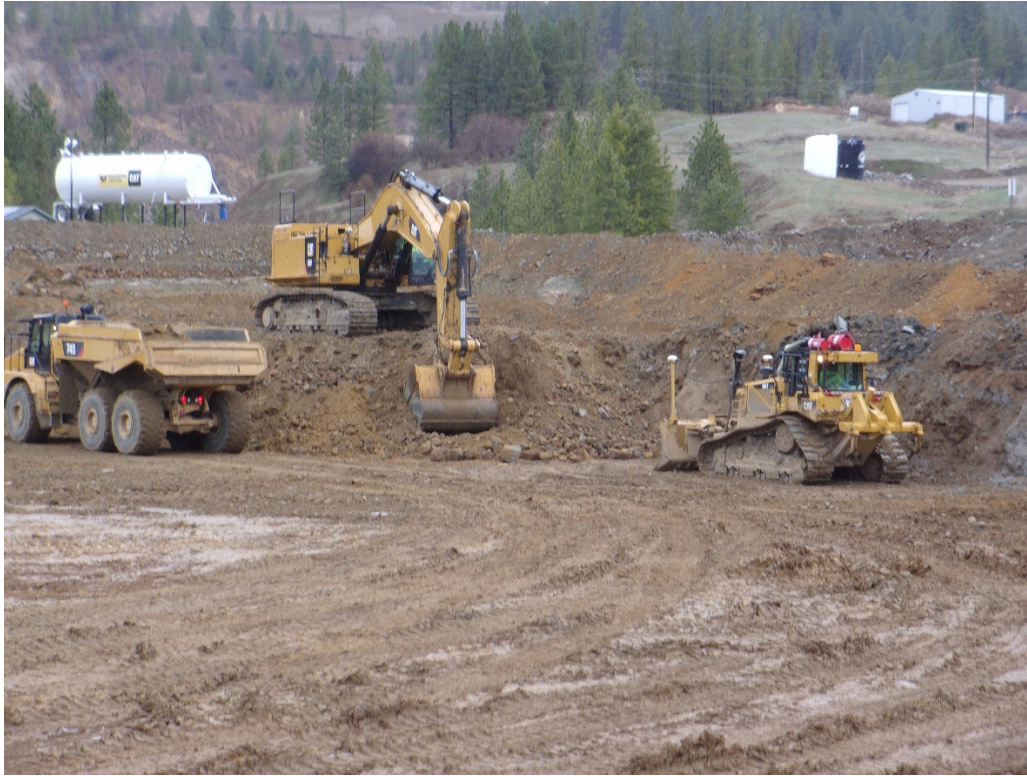
Figure 1 – 390 Excavator Loading haul trucks at Stockpile 8. The D6 Dozer is cutting material to the South Pond crest elevation.

- Excavating, hauling and placing material from the Lime Protore Stockpile 8 (Stockpile 8, low reactivity material, Figure 1), Ore Stockpile 4 (Stockpile 4, high activity/high reactivity material, Figure 2), and South Waste Rock Pile (SWRP, low activity/low reactivity material) continued. Material from SWRP and Stockpile 8 were placed on the east and west side of Pit 4 to create the 20' rind buffer area. Some material from SWRP was placed at the south end of the pit to start forming the 20' rind for the top surface. The materials were excavated with either excavator or loader equipment and transported and plug dumped with haul trucks. The plug dumps were leveled with a dozer into lifts not exceeding 10' thick. Table 1 presents the 2019 Pit 4 mass haul materials volume.

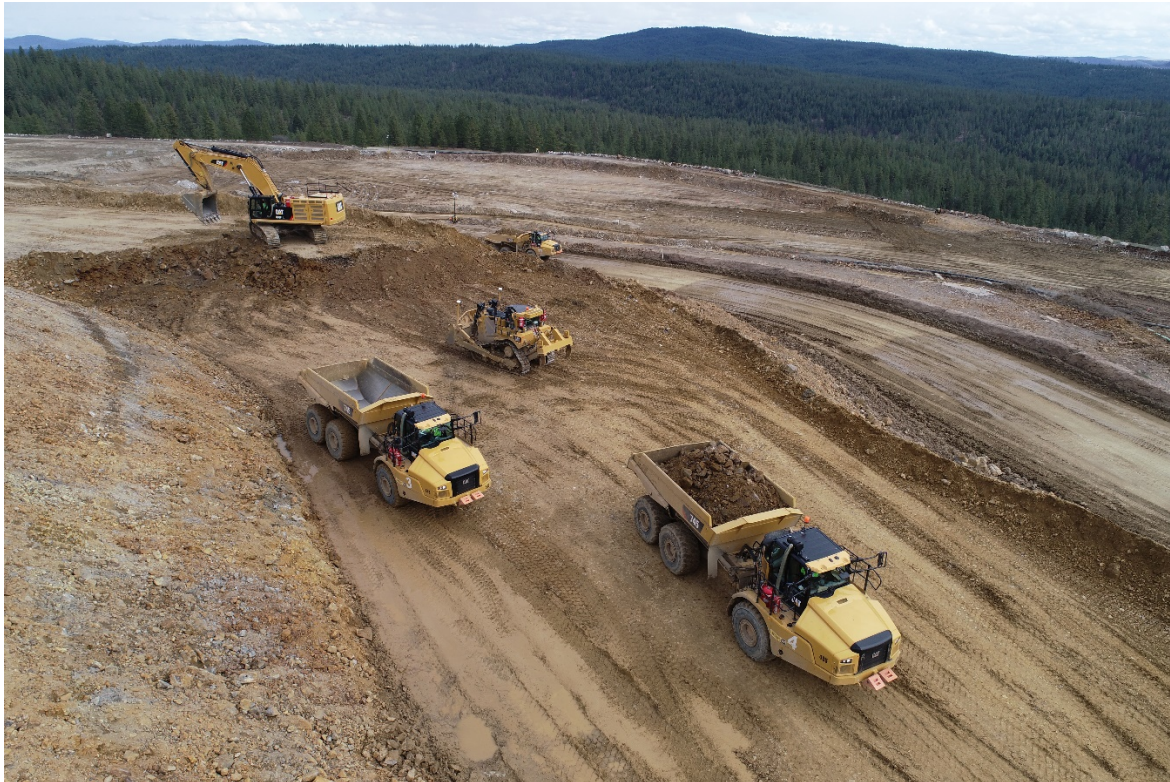
Figure 2 – 390 Excavator loading haul trucks at Stockpile 4 while the D8 Dozer, using GPS machine control, maintains a level cut floor

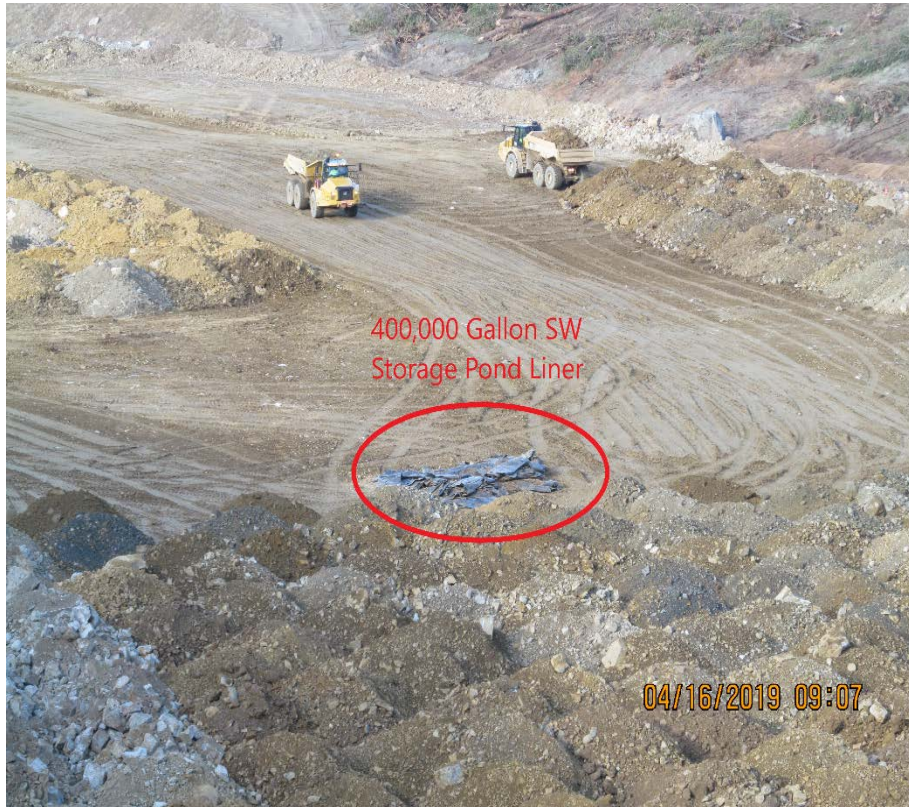
Figure 3 – 400,000 Gallon Stormwater Storage Pond liner placement within the demolition debris zone in Pit 4, looking southwest

- The liner from the Stormwater Storage Pond (400,000-gallon pond) was disposed of in Pit 4 (Figure 3). CQC personnel verified that the liner was greater than 50-feet from the risers and pit walls and was placed in a lift less than 2 feet thick.
- Fogle Pump and Supply, Inc. removed the backup pumps from the Pit 4 vertical dewatering risers and stored them in Area 5 on April 16th. The pumps will remain onsite for deployment if the pumps in the Horizontal Dewatering System (HDS) fail.
- Began relocating the HDS generator to the area of the HDS Vault.
- Pit 4 tension crack was measured on April 15th. The horizontal distance between movement pins remains at 53.75 inches.
- Extensions were added to the vertical dewatering riser on April 17th (Figure 4). The risers now extend down 210' to the Underdrain Sump (UDS) and 170' to the Waste Rock Dewatering Sump (WRDS).

- The 400,000 Gallon Storm Water (SW) Storage Pond liner was removed and placed in Pit 4 within the limits of the Demolition Debris Zone in the northern middle portion of the pit at an approximate elevation of 3168. The liner was tracked over by a dozer to consolidate the material into a height of less than 2 feet and then buried during regular backfill operations.
- Pit 4 HDS Pump System
 - The Contractor is in the process of moving the HDS pump system generator to a new location located adjacent to the HDS pipe vault in Area 5.

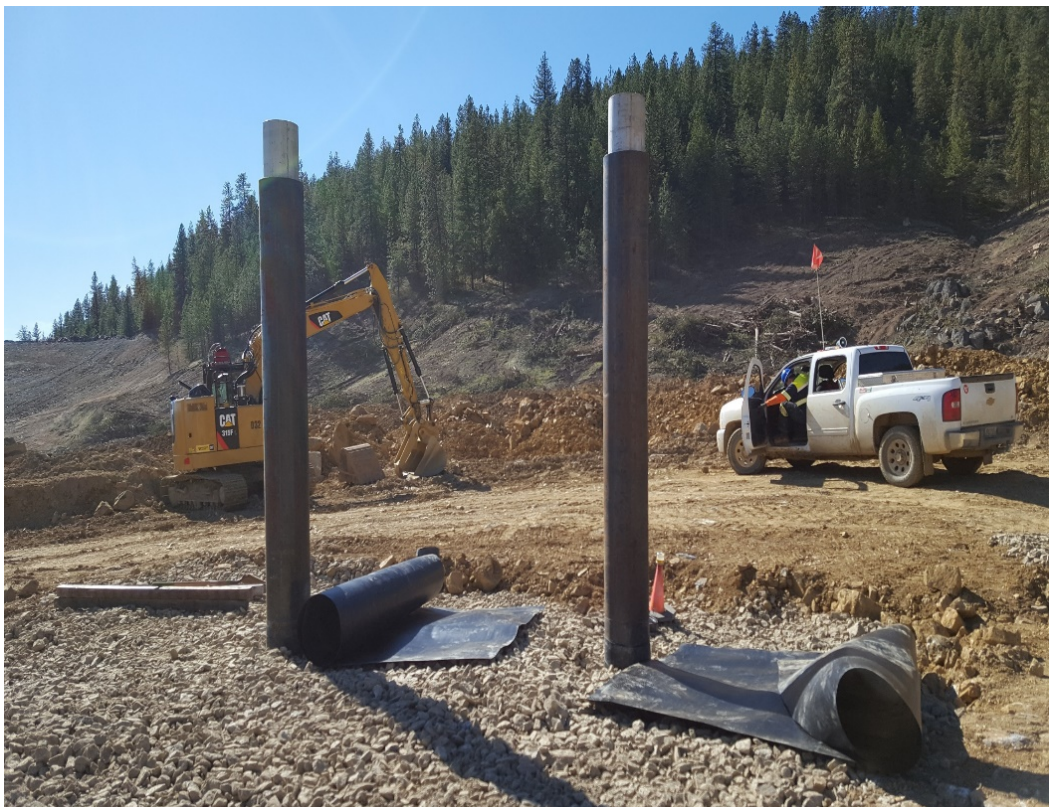
Figure 4 – Newly Installed Pit 4 WRDS Risers and Friction Sleeves, Looking West

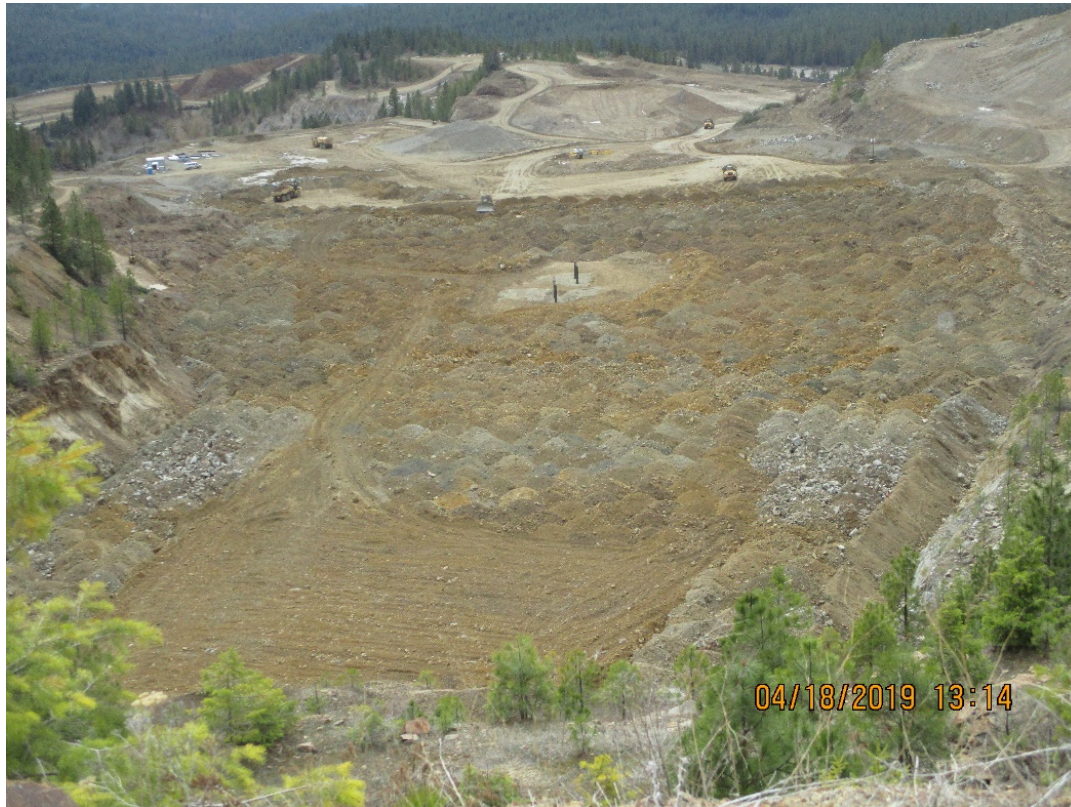
Figure 5 – Pit 4 backfill looking south, as of April 18th

- Pit 4 Backfill (Figure 5)
 - Mine waste excavated from Stockpile 8 (high activity/low reactivity), and the South Waste Rock Pile (low activity/low reactivity) was placed along the edges of the pit to construct the

20-foot buffer zone (rind). Mine waste excavated from Stockpile 4 (high activity/high reactivity) was placed in areas of the pit bounded by the 20-foot buffer zone.
